## Fungal Degradation of Military Assets

Brenda Little, Patricia Wagner, Dennis Lavoie and Richard Ray

Naval Research Laboratory  
Stennis Space Center, MS 39529

### ABSTRACT

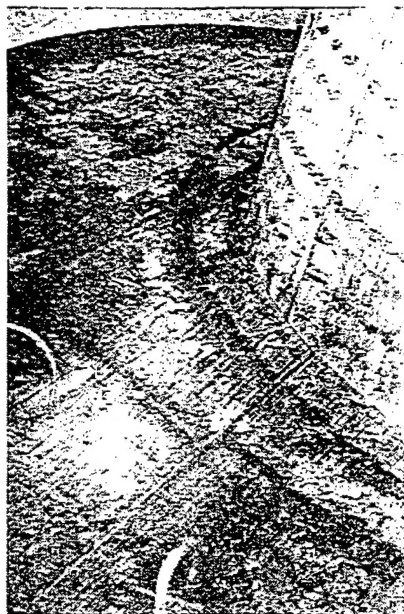
Figure 2 - Inside surface of wooden spool; white deposits are the result of fungal growth.

Sections of wood from spool interiors and pieces of brown shipping paper from spool rim edges (Fig. 2) were removed. Wood and paper samples with fungal fruiting bodies, spores, or mycelia were placed in Petri dishes with potato dextrose agar (PDA) and incubated in a dark room at 37°C. After a 1-week incubation, fungal species were identified as *Aspergillus niger* and *Penicillium* sp. The pH of the condensate within Petri dishes and in areas adjacent to growing fungi were monitored using a microelectrode with a tip diameter of 2.4 mm vs. saturated calomel reference electrode. Condensate in Petri dishes where either isolate was grown dropped from a pH of 7.0 to 4.9 in three weeks. Coated wire rope was exposed to pH 5.0 citric acid solution. Localized corrosion (Fig. 3a, b) was observed in each location the acid solution touched the rope.

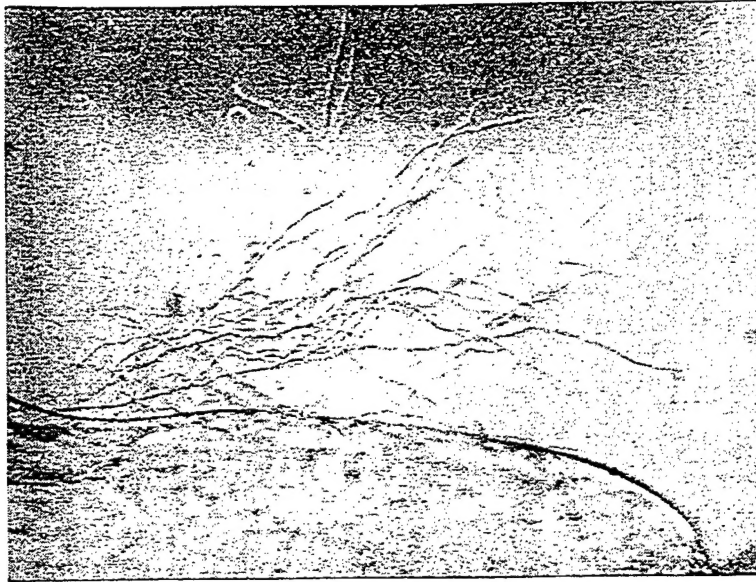
Figure 10 — Fungal mycelia in association with water droplets in jet fuel.

Extensive localized corrosion of the bottoms of carbon steel jet fuel storage tanks with subsequent leakage of fuel oil was recently investigated. *Hormoconis* (formerly *C. resinae*), *Aspergillus*, *Penicillium* and *Fusarium* were identified in the fuel/water mixtures. Corrosion attack was located near the tank bottom at the fuel/water interface where an active microbiological population was associated with free water. Fungi were observed growing over the entire surface of oil droplets and within suspended water droplets (Fig. 10). In the absence of water, no fungi were detected. Water soluble biocides are routinely added to fuel to prevent microbial growth. Problems occur when the biocides are exhausted or the amount of water has been underestimated. Attempts to form emulsions of fuel/water combinations accelerate fungal growth by increasing the surface fuel/water interfacial area and, therefore, the availability of oil, oxygen, and nutrients.
